CITY OF BALTIMORE WET W SMOKE AND DYED W	Page 1 of 7	
Sewershed: JONES FALLS	Company: REI/DRAYCO	Date: 07/23/2008
Test to be Performed: SMOKE	Ground Condition: DRY	Supervisor: ER
Manhole ID: S35KK_026MH	Test ID: 0994-364	Notifications Made:_X (Residents, Fire, 311)

# CITY OF BALTIMORE SMOKE TESTING OBSERVATION SUMMARY JONES FALLS SEWERSHED

BALTIMORE CITY PROJECT 994 REI/DRAYCO

Unique Test ID: 364 Date: 07/23/2008 Basin: JF-19

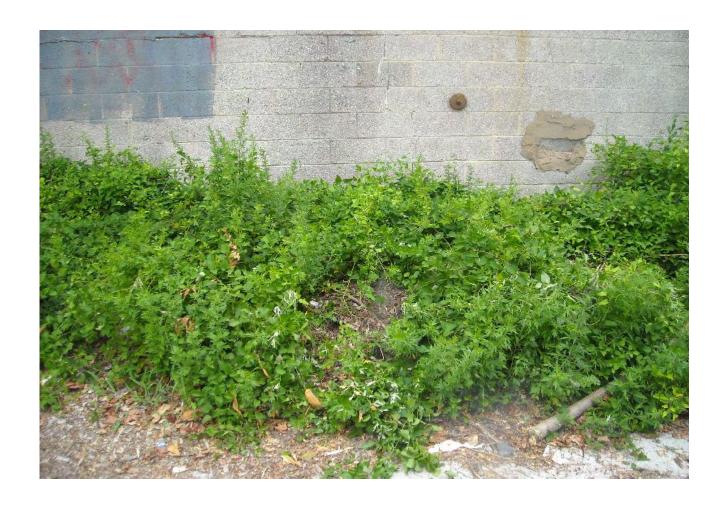
Photograph No: OB01-01 Filename: 0994-364\_OB01-01.jpg

Source Type: 02 Location: 08 Severity: 03

Comments: SMOKE COMING FROM GROUND BEHIND BUILDING ADJACENT TO TOWNSEND CT.

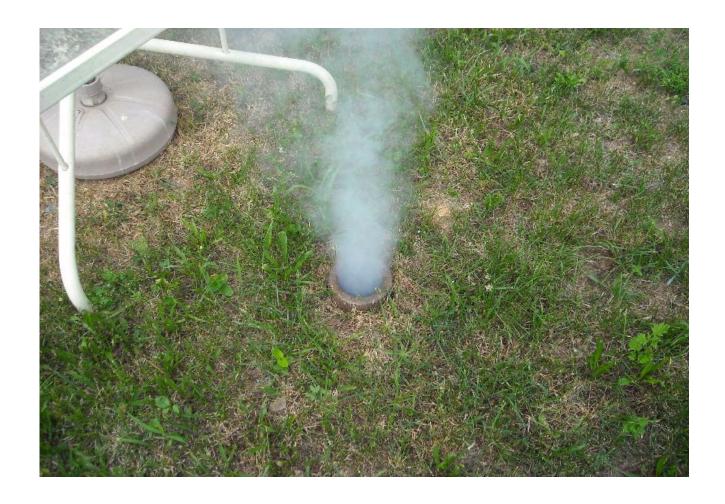
Photograph No: OB02-01 Filename: 0994-364\_OB02-01.jpg

Source Type: 03 Location: 08 Severity: 03

Comments: CLEAN OUT - ABOVE GRADE - MISSING CAP

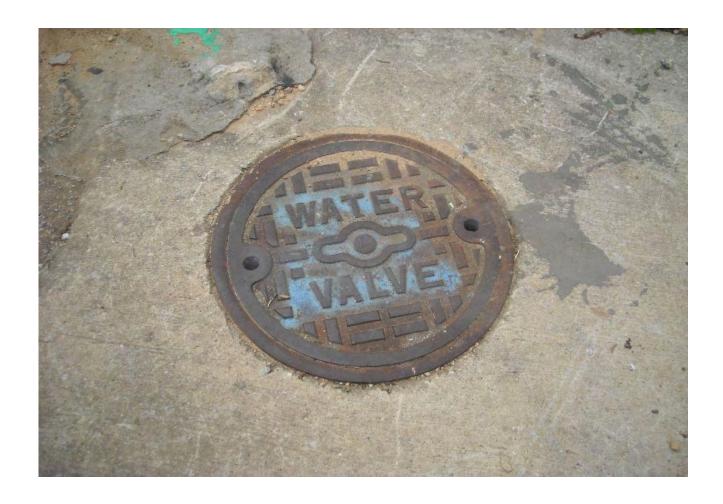
Photograph No: OB03-01 Filename: 0994-364\_OB03-01.jpg

Source Type: 16 Location: 12 Severity: 02

Comments: SMOKE COMING FROM WATER VALVE MANHOLE IN ALLEY BEHIND 322 E. LAFAYETTE AVE.

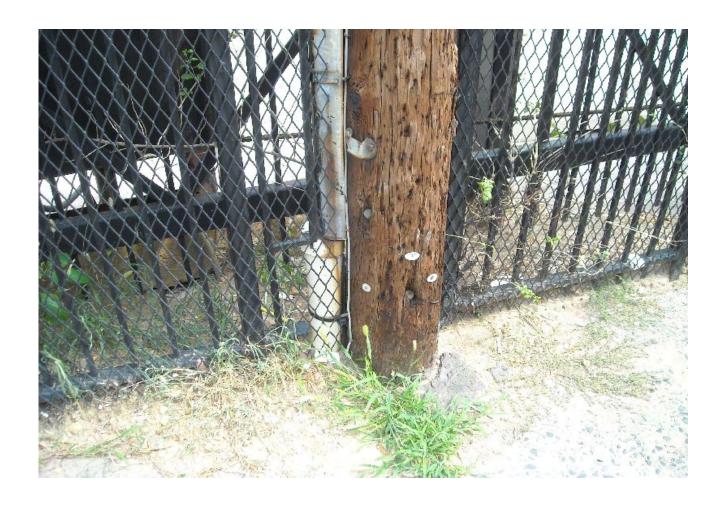
Photograph No: OB04-01 Filename: 0994-364\_OB04-01.jpg

Source Type: 16 Location: 12 Severity: 02

Comments: SMOKE COMING FROM BASE OF TELEPHONE POLE - EXTERIOR OF PARKING LOT FOR

APARTMENT BUILDING - MCALLISTER ST

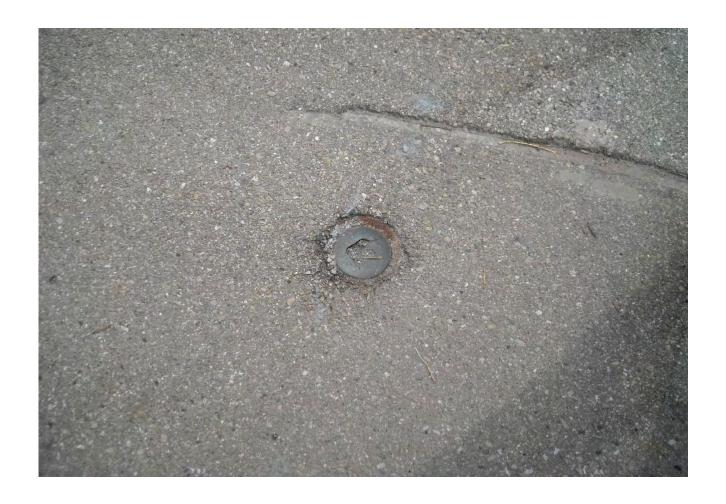
Photograph No: OB05-01 Filename: 0994-364\_OB05-01.jpg

Source Type: 03 Location: 02 Severity: 02

Comments: CLEAN OUT - BROKEN CAP - AT GRADE - LOCATION IS AT GATE FOR PARKING LOT OF

APARTMENT BUILDING - ENTRANCE IS ON MCALLISTER ST
